Manhole Inspection Summary

Manhole # S05CC2002MH

Insp Date: **8/8/06 12:00 AM**

Location Address: **6024 BERKELEY AVE**

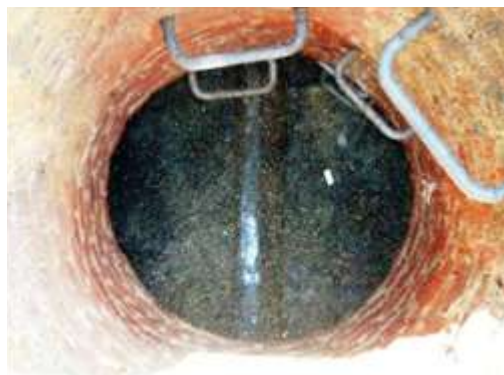
Top View

Evidence of surcharge - Bench debris.

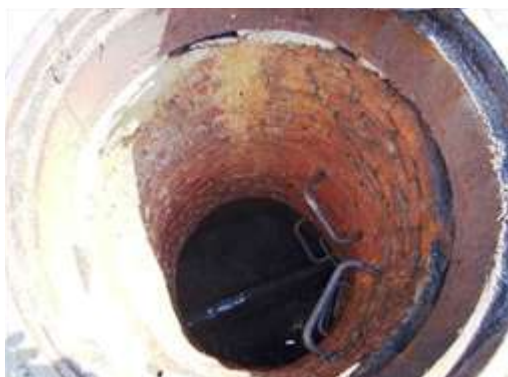
Frame leaks. Adjustment deterioration, loose brick and infiltration. Corbel infiltration.

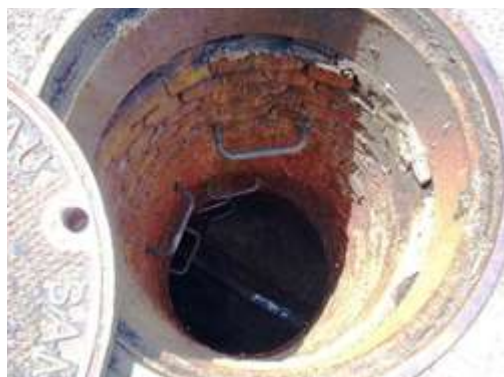
Frame leaks. Adjustment deterioration, loose brick and infiltration. Corbel deterioration and infiltration - other side.

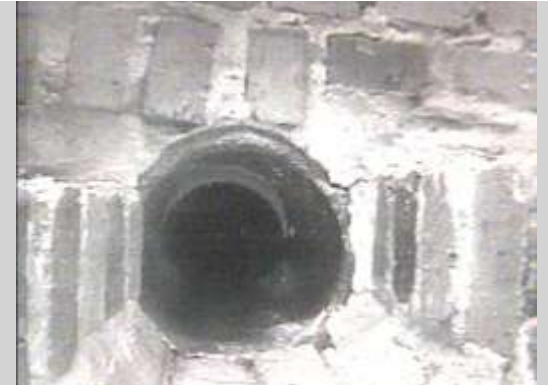
8 in. Circular Gravity Sewer Pipe Out @ 12 O'Clock

Barrel deterioration and infiltration..

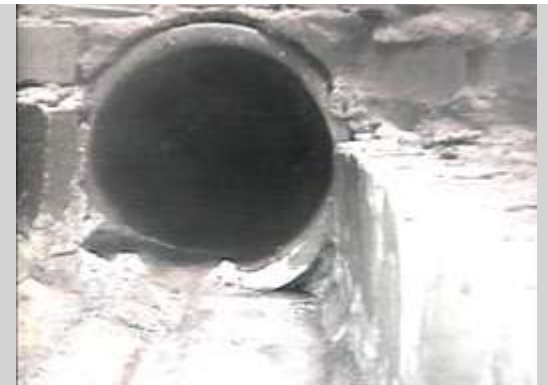
8 in. Circular Gravity Sewer Pipe In @ 6 O'Clock

Channel deterioration.
